# BOTSWANA-SOUTH AFRICA

## Joint Water Quality Project

# JOINT WATER QUALITY BASELINE REPORT

LIMPOPO BASIN BETWEEN THE  
REPUBLICS OF BOTSWANA AND  
SOUTH AFRICA

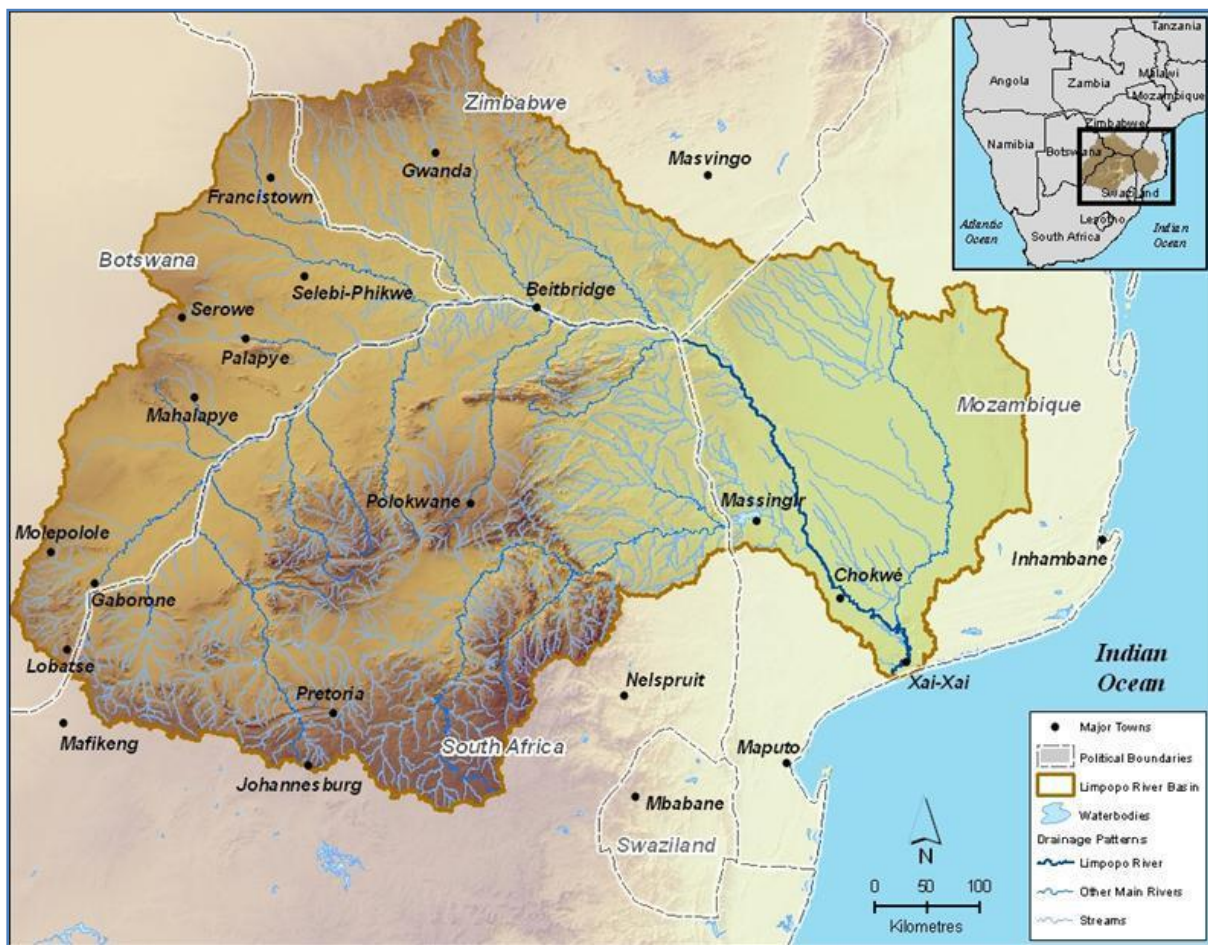
Figure 1: Map of the Limpopo River Basin

The Limpopo River basin is shared by four countries: Botswana, South Africa, Zimbabwe and Mozambique (Figure 1). The total catchment area is approximately 408,000 km<sup>2</sup> and the river stretches for approximately 1,770 km starting in South Africa<sup>4</sup>, flowing up north where it creates the South Africa-Botswana border, then east as the South Africa-Zimbabwe border and finally south-east through Mozambique to the Indian Ocean.

The main Limpopo river starts with two main tributaries (primary rivers): Crocodile and Marico which establishes the main channel and a number of secondary tributaries - Notwane, Lephalale, Bonwapitse, Matlabas, Mahalapswe, Mokolo, Lotsane, Motloutse, Mogalakwena, Shashe, Sand, Mutshilashokwe, Nzhelele, Mzingwani, Luvuvhu, Shabili, Bubi, Lumane, Mwenezi and Changane.

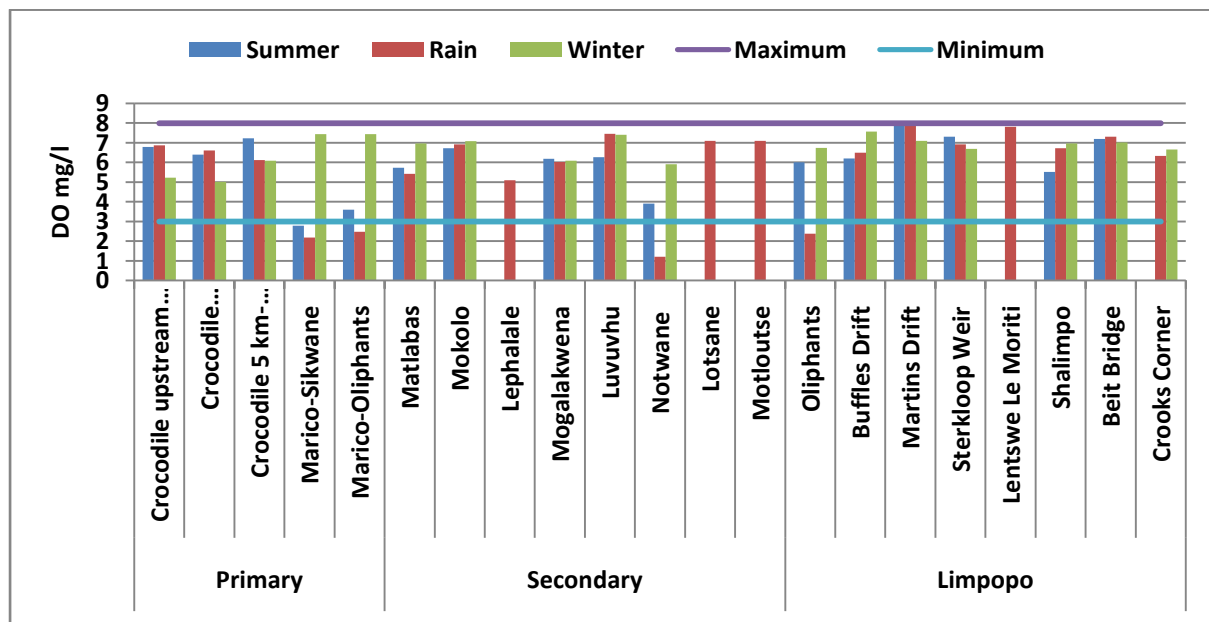
**Figure 5: Dissolved Oxygen in Primary, Secondary and Limpopo Rivers**

Dissolved Oxygen (DO) normal range is between 3 and 8 mg/L. Looking at above Figure 6, it was observed that DO is generally lower at Marico-Sikwane, Marico-Olifants, Notwane and Limpopo-Olifants mostly in rain season. This could be attributed to influx of sediments as a result of run-off. During the rain, there is runoff from agricultural land, carrying along pesticides, fertilizers, and sediments. Furthermore there are treated effluents from waste water treatment facilities being discharged into Notwane River.

DO at less than 3 mg/L is normally considered low, which reflects decomposed state. If DO is low it translates into a lot of dissolved oxygen being used by microorganisms to break down organic waste (decomposition). Hence lower DO values at the above mentioned sites can be attributed to pollution.

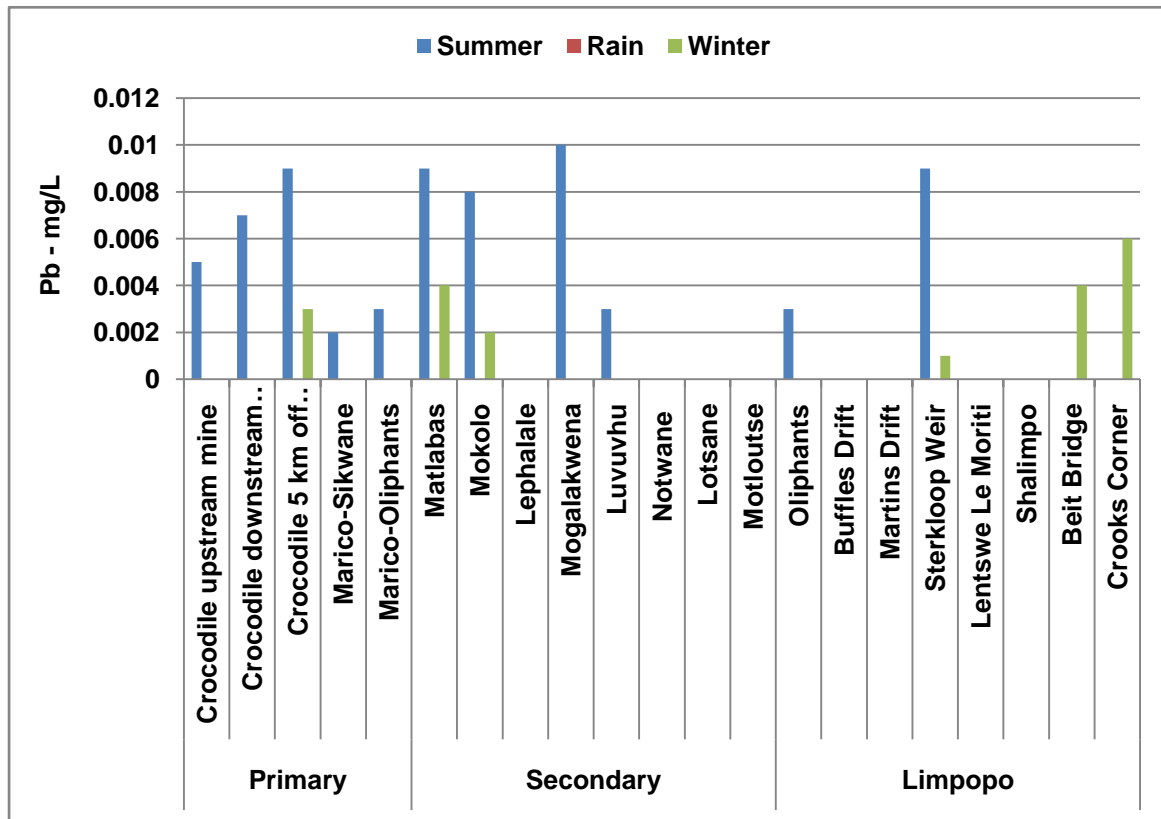
Figure 18: Lead levels in the Primary, Secondary and Limpopo Rivers

The maximum allowable limit for Lead for the aquatic ecosystem is described as 0.0002 mg/L. As per the maximum limit lead was found to be extremely higher in summer in some of the sites than in winter as shown in Figure 18.

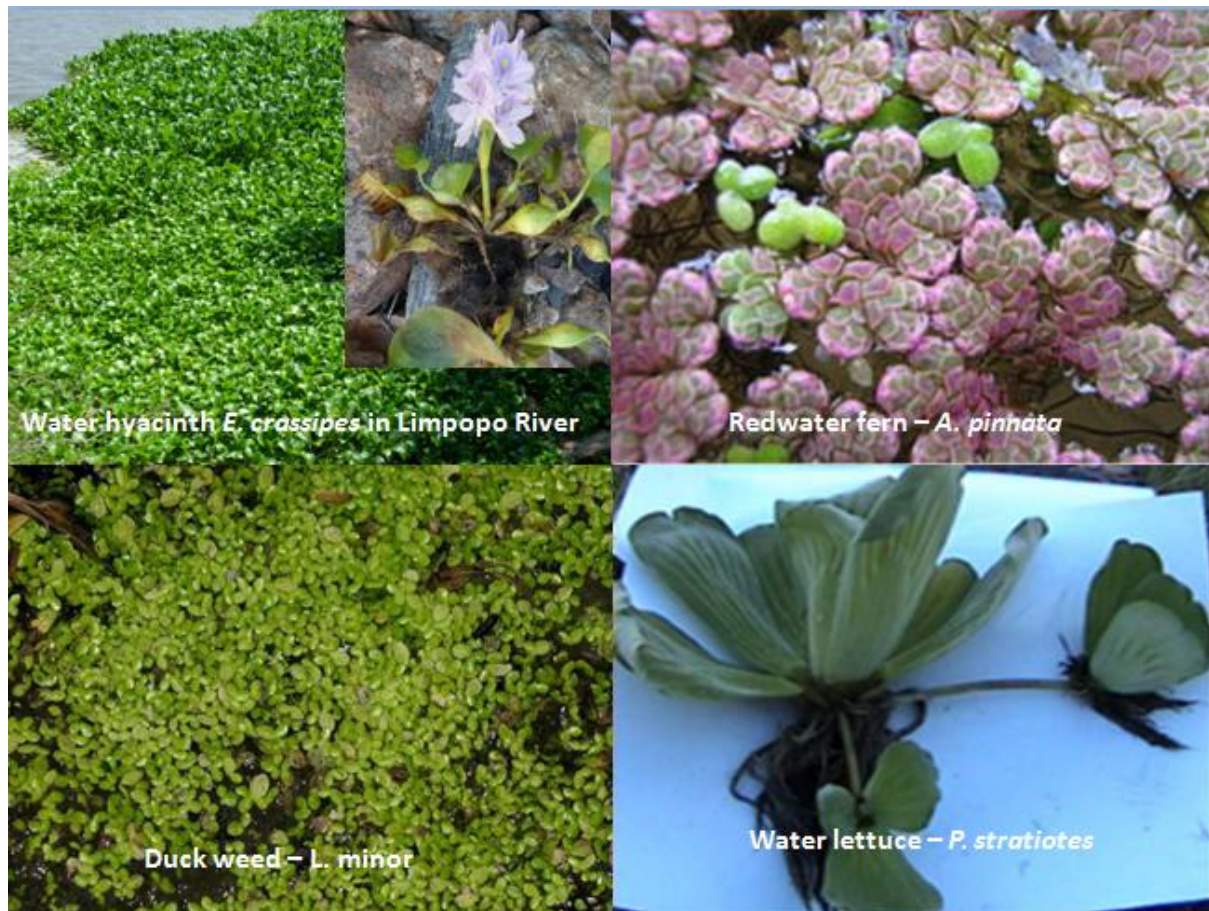
Figure 20: Invasive plants found in Limpopo Rivers - Water Hyacinth-*Eichhornia Crassipes* (Martius) Solms-Laubach, Fern-*Azolla Pinnata* R. Br., And Duck Weed-*Lemna Minor* L, Water Lettuce-*Pistia Stratiotes* L., Redwater
